MULTIDISCIPLINARY  
CONSERVATION

ICOM-CC INTERIM MEETING

## Conservation of the House of Owls at Villa Torlonia in Rome: an example of Architecture and Decorative Arts

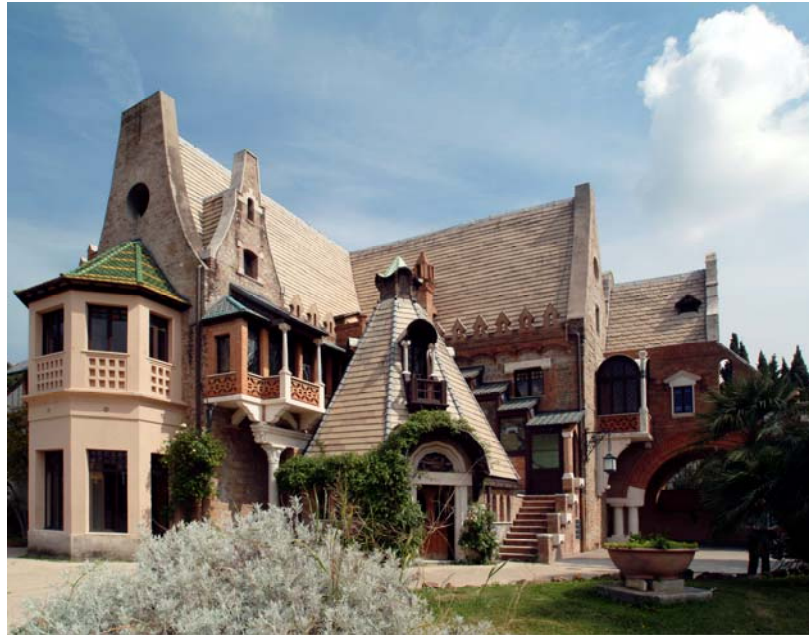
Figure 1: The House of Owls today

Among these buildings the most peculiar is *Casina delle Civette*, or “House of Owls”, so-called because of the rich architectural decoration of images of the nocturnal animal that are represented throughout [2]. The origin of the house dates to 1840, when the Venetian architect Giuseppe Jappelli designed for Prince Alessandro Torlonia a rustic farmhouse, initially named the Swiss Hut, constructed to decorate a section of the park in the fashion of English gardens. Several renovations and refurbishments that took place between 1909 and 1930 completely changed the structure of the building, transforming the rustic hut into an elegant and eclectic cottage, with interiors richly adorned and furnished, resplendent in color (Figure 1).

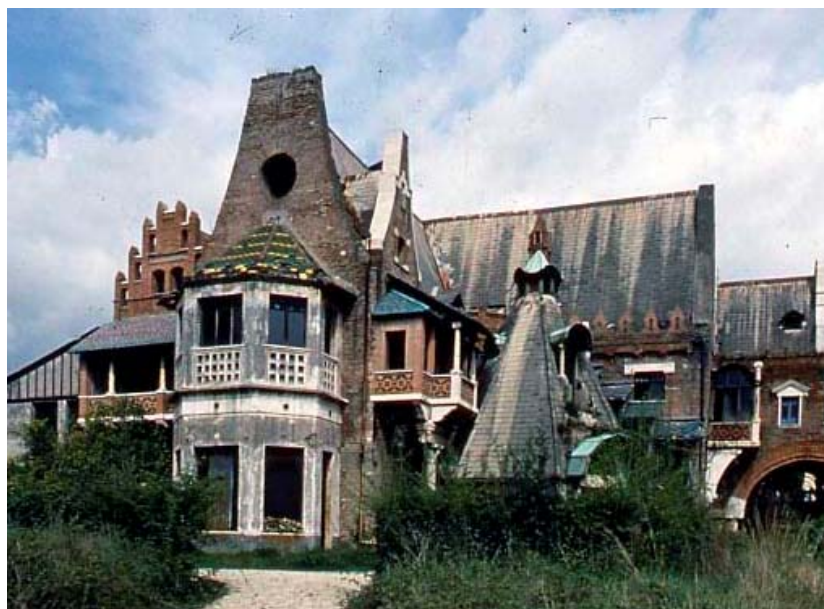
*Figure 2: The House of Owls before restoration*

It was difficult to imagine such decorative richness amidst the total ruin of the building, caused in the first place from damages produced by the Allied Army and then from decades of abandonment with subsequent thefts and vandalism. Some photographs show how the House of Owls looked at the moment the conservation project began: a fire had destroyed the roofs and burned a good part of the wood panelling; the painted wall decorations were damaged by the infiltration of rain water and in part had disappeared; the stucco elements had detached from the walls and had in places fallen to the ground; marble pieces were cracked and transformed into chalk by the fire; the colored maiolica, part of the external aspects of the roofs, had collapsed in part and laid scattered on the ground or been lost completely; vegetation had invaded all interior spaces producing further damage; the glass windows were fractured in multiple places and many were lost entirely. Some empty doors and windows, deprived of original glass, which disappeared at an unknown date, appeared outright desolate. In short, only a few tattered remains of the materials that covered many walls with elaborate designs and vivid colors still existed, those representing stylized owls remain particularly evocative.

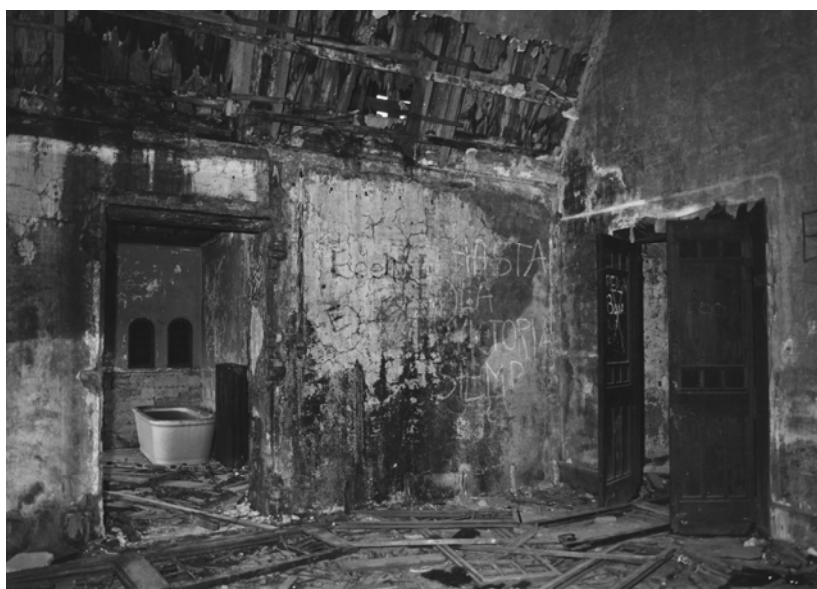
The situation in 1993 was disastrous. The conservation of all elements needed to be carried out contemporaneously: recovering architecture structures and making them functional while at the same time reconstructing the incomplete decorative elements. This meant restoring the surviving decorative elements that remained amidst problematic gaps or even at times the total loss of entire sections. The aim was to return a certain legibility to the complex as a whole, recapturing the original harmony between the architecture and the decorative arts therein, to show again the image of that incredible and original residence that Prince Giovanni Torlonia had created. However, it was necessary to avoid arbitrary interventions, not based on documentary evidence and, obviously, to respect and preserve, in the best possible fashion, that which had survived. The rooms of the House of Owls were completely devastated and cluttered with all types of detritus (Figure 3).

*Figure 3: The Prince's Bedroom and the Bathroom before restoration*

The first task was, thus to determine how much was possible to recover and how much was irredeemably compromised. All remaining original movable original material was moved to safe storage and all detritus was cleared from the structure. Over a period of months, all recoverable elements and fragments, indispensable for reconstructing the original, were assembled, catalogued and sorted in two ad-hoc sheds created in a nearby area (Figure 4). At the same time, all the immovable decorative elements - wall paintings, mosaics, and stucco - were protected while waiting conservation, which was planned to commence after the completion of the architectural intervention.

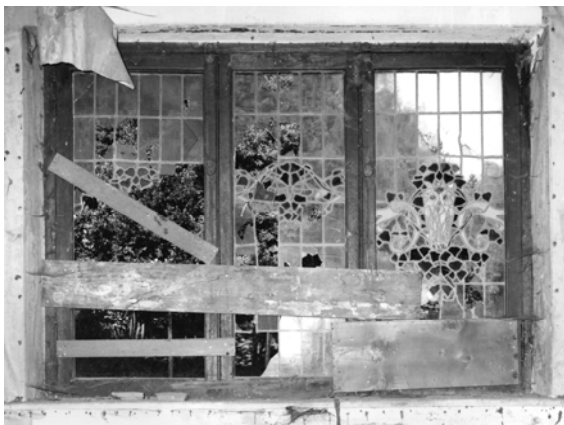
Obviously, because of their fragility, the stained glass suffered many damages and some of the panels, luckily recorded in historical descriptions and documents, were lost. The restoration of the surviving stained glass, notwithstanding the fragmentary condition in which they were found, was carried out successfully. The entire project was given to the one firm, Vetrerie d'Arte Giuliani; the same firm in fact which had, 70 years before, produced the stained glass for the House of Owls (Figures 5 and 6). The company Giuliani, and their master craftsmen, is still using today the same techniques and the same materials as 70 years ago. Eventually the stained glass panels were reformed; all of the detached fragments were reassembled with new lead comes and new pieces of colored glass were inserted only where the original ones were definitely lost or irrecoverable. Placed on new supports, the treated stained glass panels were put back in their original locations.

Figure 5: Diulio Cambellotti, Window with Owl before restoration

The total loss of some of the stained glass panels posed the choice whether to leave a gap or integrate a reconstruction of the missing panel, at least in the instances where the original cartoons of the designs were available or panels were part of a repeating pattern or series. After a thorough evaluation, it was decided to recover as much of the building's decorative richness as possible, either by using original cartoons to reconstruct missing elements or reproducing copies based on the design of an existing original. For instance, the four rhomboid glass panels with migratory birds and those the representation of the seasons, both sets designed by Diulio Cambellotti, were recreated using cartoons, while the ovals with climbing vines and grapes, also by Cambellotti, were reconstructed based on existing originals. The date and hallmark of the firm Giuliani were included along the border in order to identify the new stained glass panels. When, on the contrary, no information existed about missing stained glass panels, the decision was made to leave a gap in the decorative scheme, installing instead a simple transparent glass panel constructed with rectangular panes held together with lead comes.

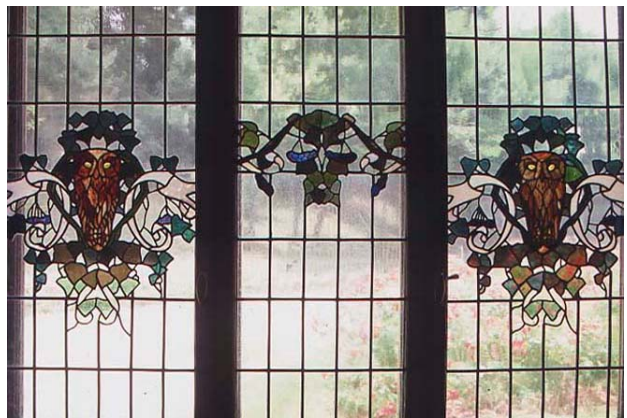
Figure 6: Diulio Cambellotti, Window with Owl after restoration

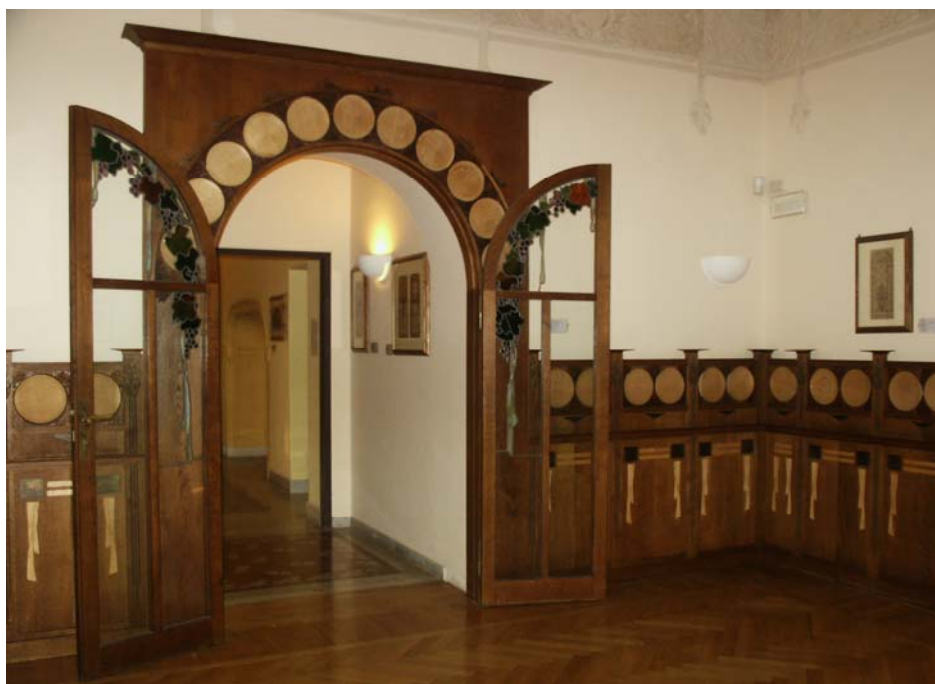
*Figure 7: Dining Room after restoration and the reapplication of the panelling*

Three rooms on the ground floor of the House of Owls were richly decorated with wood panelling. These at the start of the project were in an awful state of preservation. The precious carved wood was scattered on the ground, in part burned by fire, in part reduced to irrecoverable fragments. The choice regarding what type of intervention should be undertaken was not easy. This was only made after a careful survey revealed what could be recovered and a further research of the archives was completed. It was decided to restore and complete as much as possible of the panelling in the dining room as it was less damaged (Figure 7), but to leave panelling in other rooms in a more fragmentary state. Some surviving fragments from the other two rooms were also restored, bearing witness to the original fixtures but without proposing a reconstruction that would have inevitably been arbitrary.
