Historical and Methodological Aspects of the Restoration of a 18th century French Gilt Leather Tapestry in an Historic House: the Maison Mantin project (Moulins, France)

Céline Bonnot-Diconne, Conservator, Centre de Conservation et de Restauration du Cuir, Moirans, France

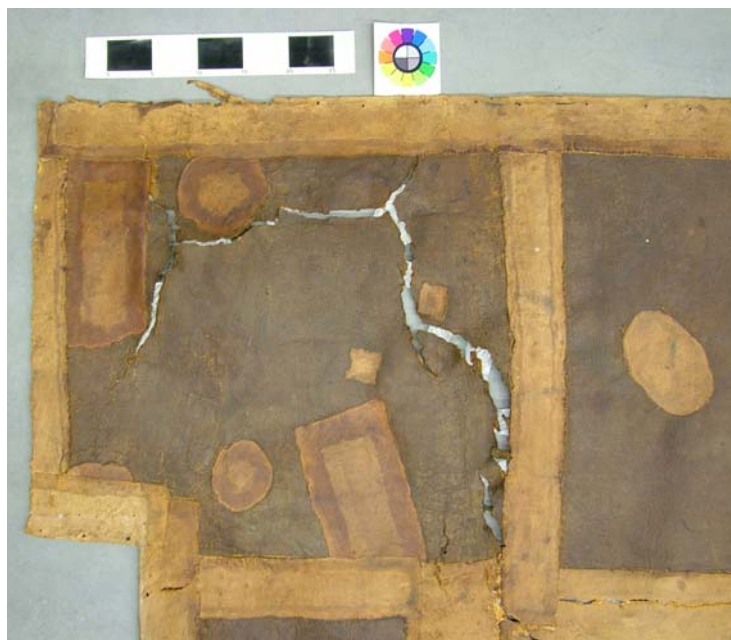
Figure 2: Presence of modern leather backings on the panels which led to splits. © C.Bonnot-Diconne 2009

Used extensively as strips or as repair patches, their weight as well as the glue used, caused excess tension and stiffness and as a result splits have appeared. But more importantly the type of leather used played a significant role in how the wall hanging reacted. Analysis has shown that this vegetable-tanned leather did not react to environmental conditions in the manner as the original leather. This modern leather stretched, lost its shape very rapidly and was by nature not very resistant.

As a result of removing the modern leather backings, the individual elements were separate and had to be rejoined using strips of non-woven polyester of different qualities (17g per sq. m and 35 g per sq. m) using a layer of Beva 371® glue. In order to hold the edges together, the splits were repaired similarly; then any gaps remaining were filled using a Beva 371® filler coloured appropriately using acrylic paints (Figures 6 and 7). The edges of panels were reinforced with strips of 5 cm wide Velcro® sewn onto a sheet of polyester cloth. The polyester fabric was adhered to the reverse of the leather panels using Mowilith DMC2®. Distilled water

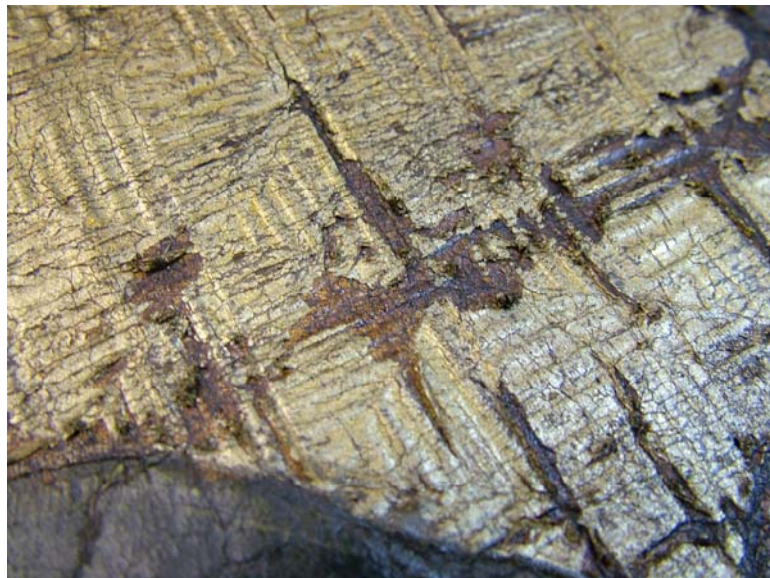
The 19th century craftsmen “improved” the decorated side to give the illusion of a uniform surface and to make the coloured motifs stand out even more. The background of each scene was completely repainted; this thin layer of colour, applied with great precision, covered up the original gilt background which remained visible in very few places (Figure 3). Analyses carried out by the Centre for Innovation and Research, Analyse and Marks (CIRAM) have shown the overpaint contained chrome yellow, used only from 1820 onwards. Tin foil, invisible to the naked eye, was discovered on top of this chrome yellow layer. The question posed during the current conservation was whether to keep this gold coloured overpaint or to remove it. Unfortunately, the original gold imitation varnish underneath was extremely fragile and could not be cleaned without taking risks. It was therefore decided to keep this gold coloured wash overpaint.

Figure 3: Chrome yellow based gilt colour on the original backgrounds. © C.Bonnot-Diconne 2009

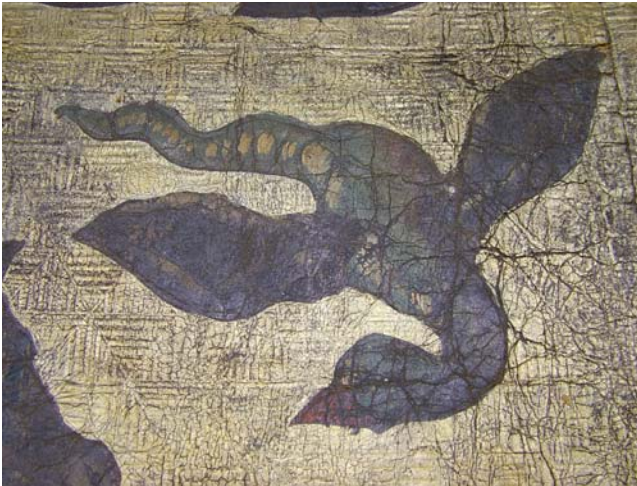
On the other hand, the decision to remove the a thick coat of varnish covering the paint could be made separately. This varnish had darkened, and while in areas it was flaking off, in others it was powdery. The analyses, carried out by CIRAM, identified a mixture of amber and a resin suggesting that it was a “Chinese varnish”. Although this varnish layer could not be removed safely from the fragile background areas, The removal of this oxidised material from the coloured areas brought fourth their original tonalities uncovered by the 18th century overpaint: clothes in a great number of bright shades and colours; faces with creamy, pink coloured skin etc ... (Figures 4 and 5). Flaking paint noticed in various places prior to treatment, was in fact simply the damaged varnish delaminating. The varnish could be swollen by using polar solvents in gel form

Figure 4: Detail of a bird before removal of the varnish on the paint. © C.Bonnot-Diconne 2009

to which a wetting agent was added; it could be removed by rubbing very gently with cotton wool. Using this technique was a long and laborious task because it had to be adapted for each colour and each area because of the differences in the thickness of the varnish and the reaction of certain pigments (notably the blacks and browns). Moreover, the areas covered by the gold coloured wash overpaint had to be avoided at all costs.

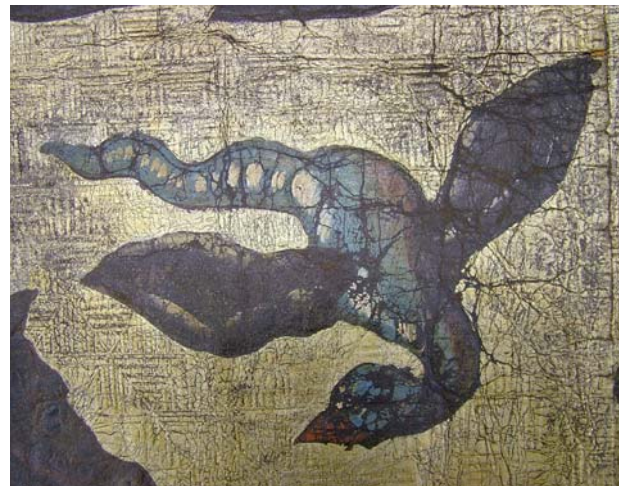
Figure 5: Detail of a bird after removal of the varnish on the paint. © C.Bonnot-Diconne 2009

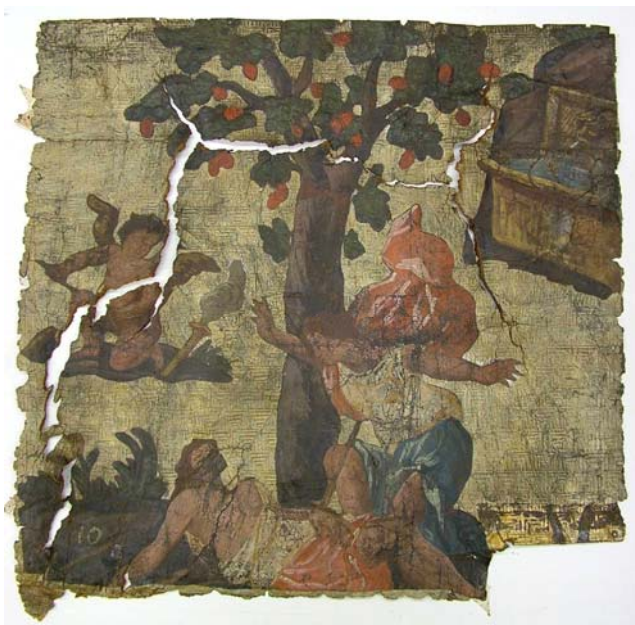
Figure 6: Torn panel before restoration. © C.Bonnot-Diconne 2009

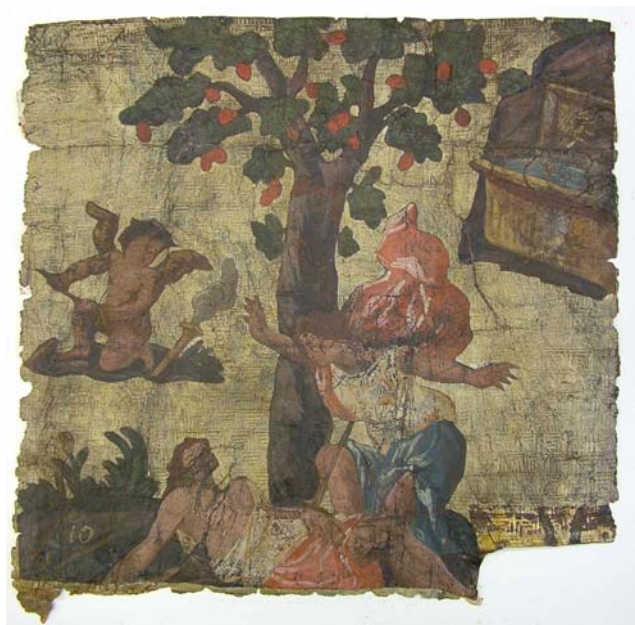
Figure 7: Torn panel after restoration. © C.Bonnot-Diconne 2009

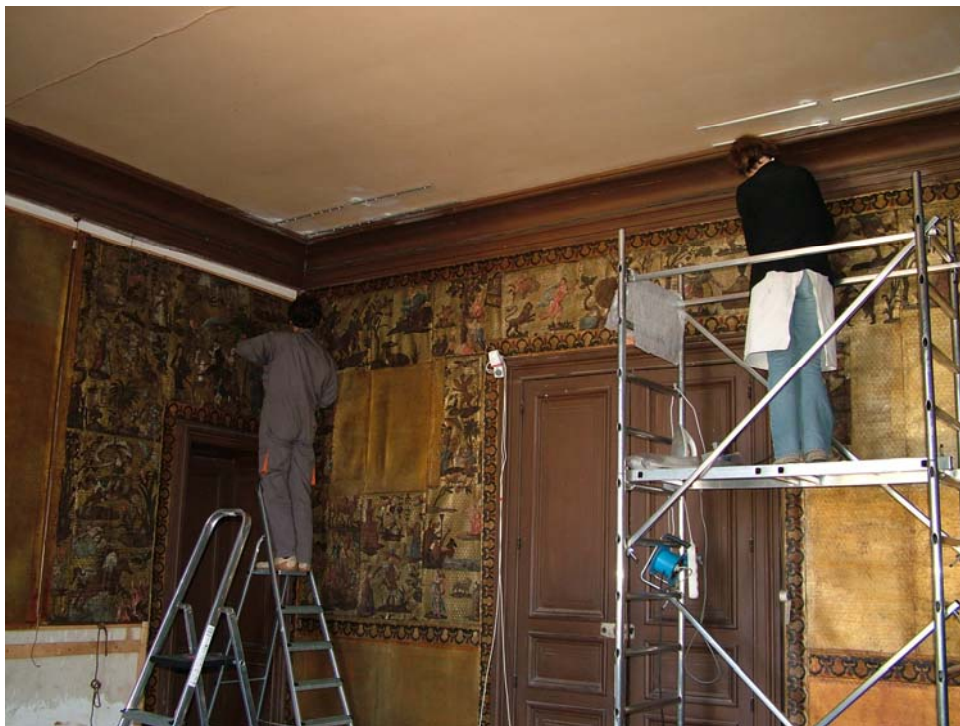
Figure 8: Decoration being put back into place. © C.Bonnot-Diconne 2009

The strips of leather covering the joints were meticulously conserved as they acted as a frame for the leather surfaces and were visible at in front of the decoration. The dust was removed from the strips with a microfiber cloth. Then all the gaps were filled (Beva 371® filler) and afterwards retouched using acrylic paint. Many had lost their original shape and were torn, so these were backed, either partially or completely, with non-woven polyester adhered using a coating of Beva 371® glue. After treatment, the gilt leather panels were fixed back onto the original frame using Velcro® strips (described above) and the leather strips used to cover the joints were replaced in their original position. They were fixed with upholstery nails [2] (Figure 8).
