The mural paintings in S. Maria Maddalena church in Camuzzago: the conservation process.

This text describes the pattern that has been followed for drafting the conservation plan of the mural paintings in S. Maria Maddalena church.

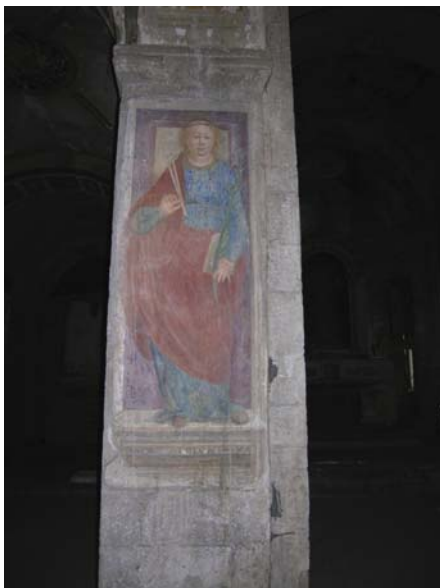
Figure 5 A fresco on a pillar (S. Apollonia)

The paintings in the choir and on the pillars are quoted in documents from the 16th century, while it is now clear that the aisle vaults were not to be painted until the middle of the 19th century. The archival information has been confirmed by direct survey. It can be observed that the aisle vaults are built upon walls coated with plasters from previous building phases. Therefore the thesis that these decorations, stylistically recent, were painted over older frescoes has been disregarded, as it is clear that they were painted *ex novo*. Laboratory tests gave one more help. The microstratigraphic analysis showed that no layer is to be found below, and some of the pigments used in the colors were in commerce only after 1920.

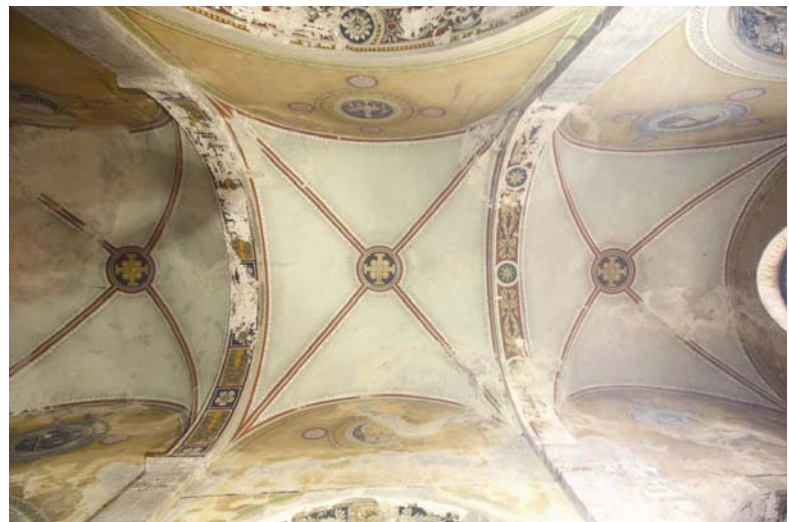
Figure 6 The nave’s vaults

S. Maria Maddalena church was built in 1152 and was embellished with frescoes by a well-known Lombard painter, Bernardino Butinone, in the first decade of 16th century and with secco paintings dated back to a period between the second half of 19th and the first half of 20th century. The Cinquecento pictorial cycle survives in the presbytery and on the apse (Figures 1,2,3,4); there are also frescoes on the pillars, representing Saints and the Virgin with the Child (Figure 5), while a series of decorations with vegetal, floral and figurative patterns cover the vaults and the walls of the nave (Figures 6,7,8).

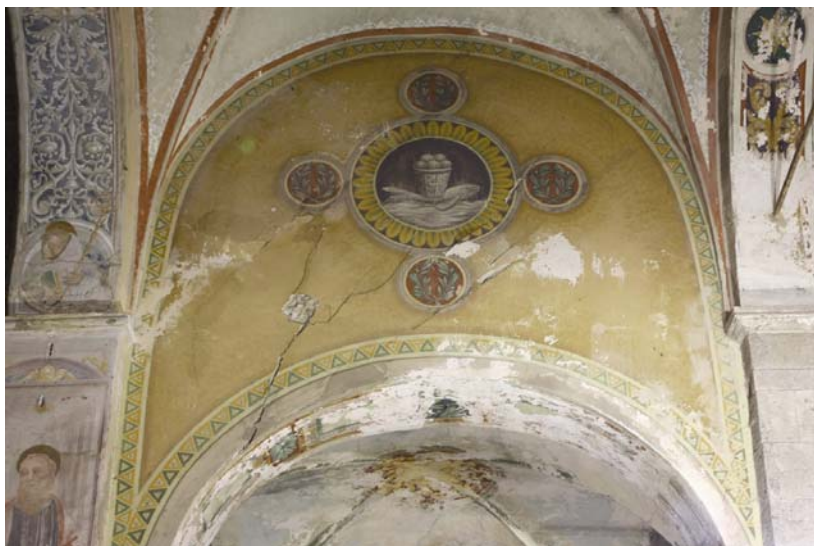
Figure 7 The nave’s decoration
