**JOINT INTERIM MEETING OF FIVE ICOM-CC WORKING GROUPS:**

## United Nations – uniting professions? Restoring the U.N. Building

*Margareta Bergstrand*

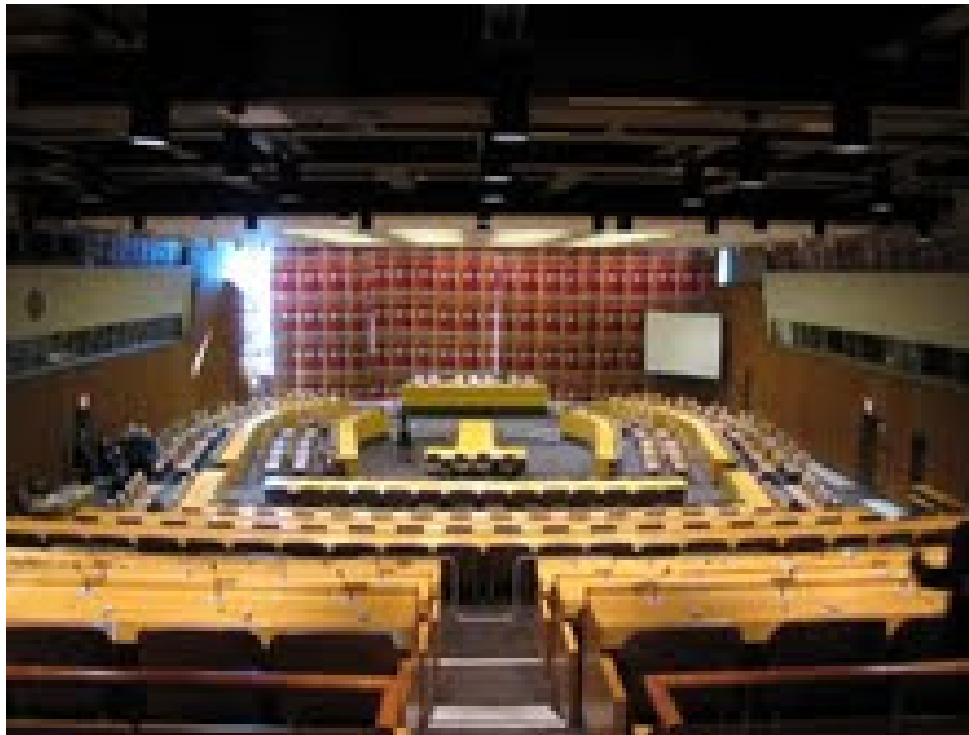
*Fig. 1: The Economic and Social Council Chamber. Interior in October 2009, shortly before renovation.*

While the Security Council Chamber with its permanent number of member seats is the most unchanged of the three council chambers, the ECOSOC has undergone several alterations over the years. The seating has been changed drastically. The first change came in 1974 when the number of Council members almost doubled. New delegate chairs were made in Italy to resemble the original ones designed by Elias Svedberg and manufactured by the Swedish firm NK-bo. Over the years the chairs have been mended and re-upholstered so that one now can find at least five variations of the chairs with vinyl covers of slightly different beige nuances. The vinyl is a poly-vinyl chloride coated textile which has been used on almost all seating in the U.N. building. The seating area for the chairpersons was raised up above the floor level by the building of a podium and the horse shoe shape of the table was changed. In 1995, Sweden financed the renovation of the floor, tables and lighting, minor repairs of cracks in the paint on the walls and ceiling, as well as cleaning of the carpet.

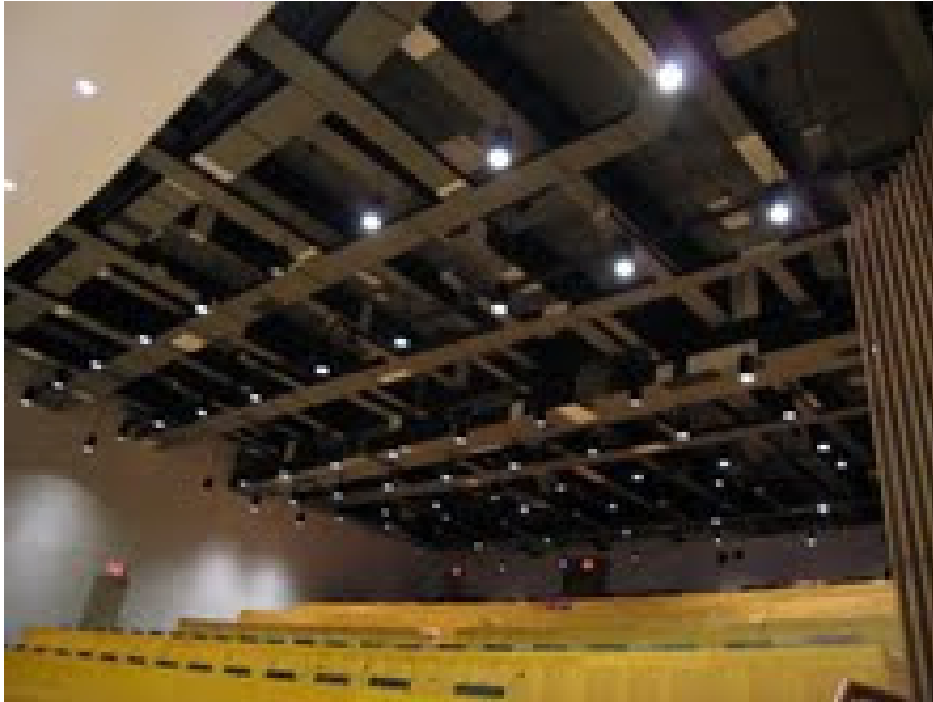
*Fig. 2: The ceiling of the delegates' area. October 2009*

“The ceiling which in the delegates’ area is suspended and highly stylized, is purposely dark and unfinished in the public gallery area to symbolize that the work of the Council is ongoing”. [Betsky 2005] This is only one of the stories that can be told of the ECOSOC. Both Sven Markelius and one of his assisting architects, Bengt Lindroos deny this story, but in his memoirs Lindroos admits that it is indeed both touching and appropriate. The real reason for the unfinished ceiling was that the low ceiling in the listeners section that made Markelius devise a solution that would enable him to give the audience section a height of almost 5 meters instead of 2.3 meters. The window wall is 7 meters high by 22 meters wide. According to other stories, it was a great shock to several prominent people to see the ducts and electrical chases exposed in the ceiling of the public area. Markelius solved the visual problem by painting the ceiling in a kind of cubistic camouflage in dark green, black and white. The strained United Nations budget made this solution welcome and acceptable. It is also true that this rendering of the ceiling would soon enough be “the thing to do”, and today is part of modern architecture. [Markelius 1953, Rudberg 1989, Lindroos 2008].

The view of the Swedish National Heritage Board is that the ECOSOC chamber is changing and must continue to do so in order to serve its purpose and the intentions of the United Nations. Keeping that in mind, there are a few things worthy of preservation - one of them is the inner ceiling.

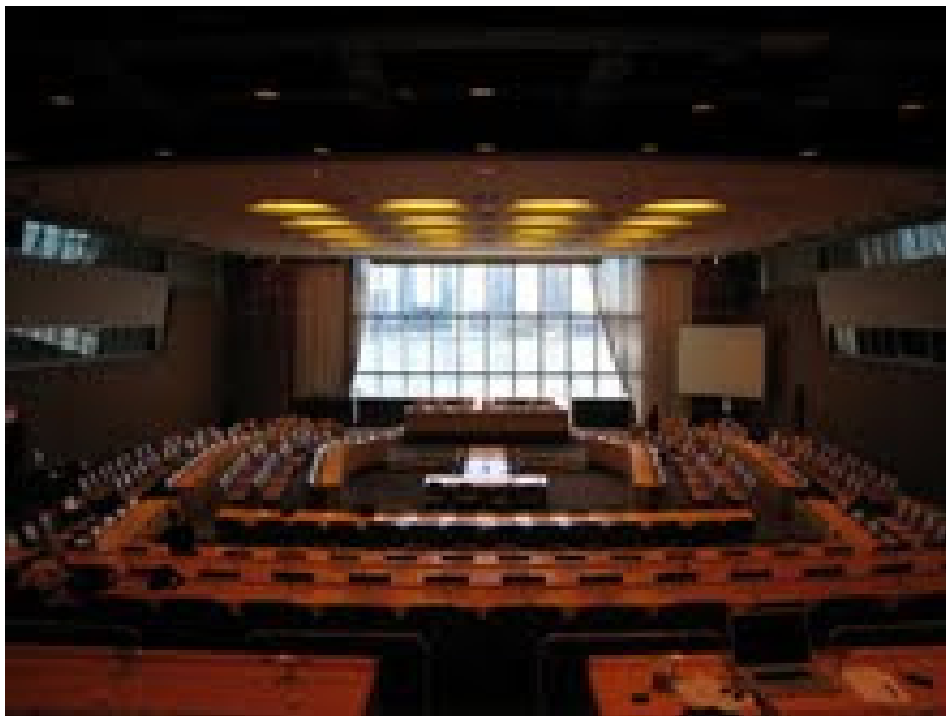
*Fig. 3.: The Economic and Social Council Chamber. A rare view of the East river with the curtain pulled away from the window wall. October 2009*

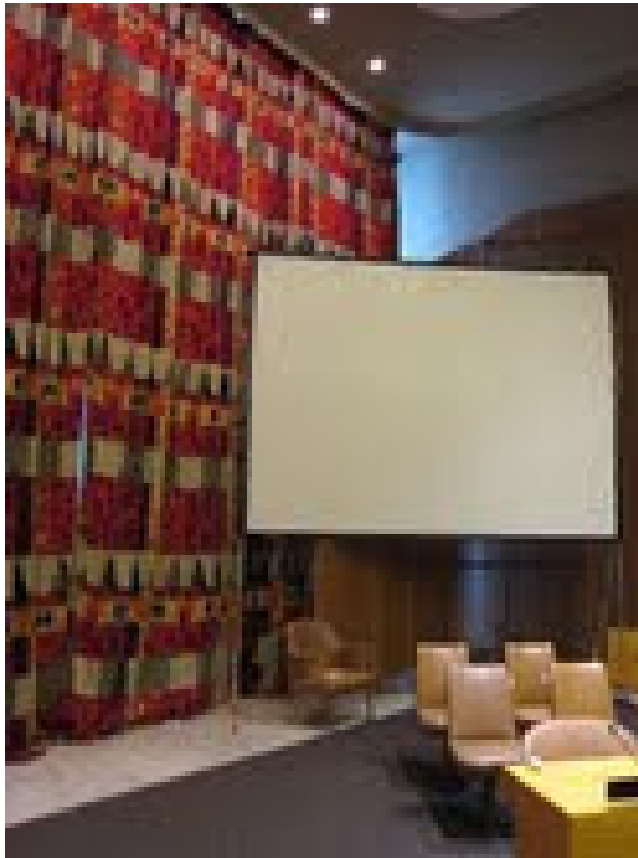
*Fig. 4: A closer view of the ‘Pythagoras’ curtain, one of the delegate’s chairs and fixed chairs. November 2008*

Today, this curtain too is badly soiled and the white parts of the pattern have yellowed, possibly due to the fact that smoking was allowed in the chamber until early 2000. Furthermore, it now shows signs of damage from fire retardants as well as from bad handling. It was fire proofed in Sweden using Pyrovatex ®CP [1] at the time of manufacture. An informal spot test performed at the site in 2008 indicated that cleaning of the curtain would not be entirely successful. Earlier attempts to wet clean fire proofed textiles have often proven unsuccessful and even disastrous [2].

Consequently, the conservators faced the question of whether to reconstruct the first original curtain or conserve the second one. The option of conserving the velvet curtain was soon ruled out – the cost of wet cleaning would by far exceed the cost of making a new curtain from a similar material. The factory that reprinted the pattern in the 1980’s still stocks the print but in a material other than the original cotton velvet. Today, the pattern is printed on velvet made from synthetic fibres that contain flame proofing agents which might meet the requirements of the New York City Fire Code.

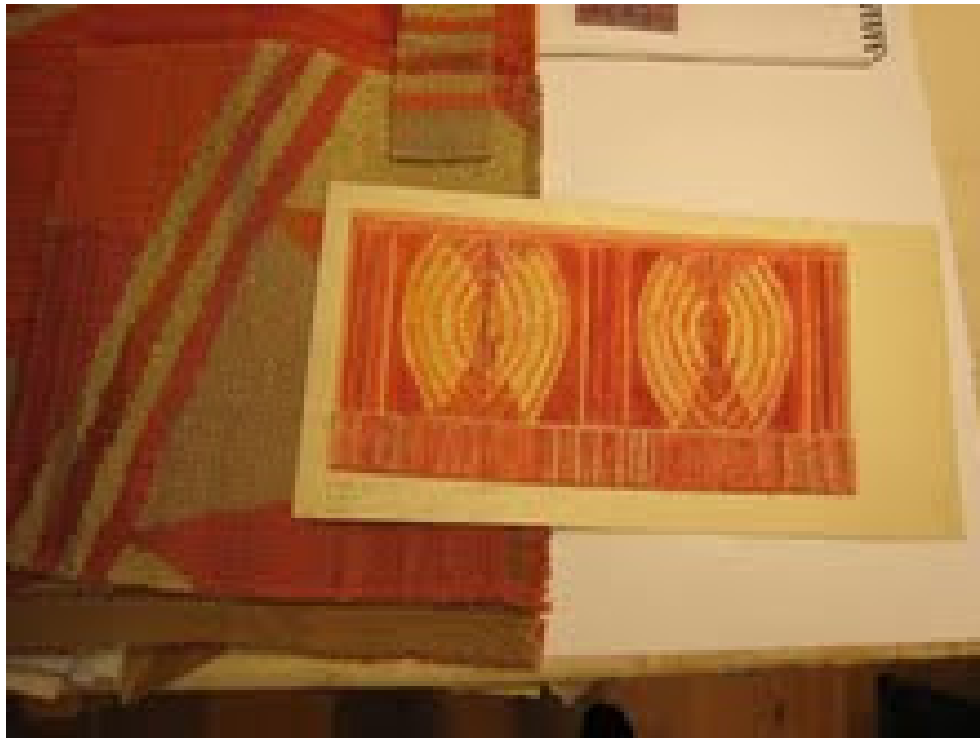
Fig. 5: Pieces of the lost curtain and one of the many sketches for it, designed by Marianne Richter.

Already by the early 1960’s the draperies showed signs of degradation. In 1965 it was sent back to Sweden where it was treated and washed by one of Marianne Richter’s former students who also did some support sewing. After treatment it was sent back to New York and rehung in the ECOSOC. In accordance with the laws of the city of New York, the curtain had been treated with a flame proofing agent probably before it was installed in 1952. It is not known today if this treatment was repeated after the wet cleaning took place in 1965. What is known is that its condition rapidly got worse and new

treatments were considered. It is suspected, but not confirmed, that a chemical dry cleaning was performed. In the early 1980’s, the condition was so bad that the curtain was taken down. At the artist’s request some smaller pieces were sent back to Sweden and to the Märta Måås-Fjetterström workshop. One piece remains in the Minneapolis Institute of the Arts. It is one of the lost great works of art of Swedish modernism.

One would hypothesize that the curtain was affected by a combination of the flame retardant treatment, sunlight, humid climate conditions, and bad handling. However, since the quality of material and technique was of such a high level, the catalyst for the unusually quick deterioration probably was the flame proofing agent. In 1969, Karen Finch wrote in a short note in *Studies in Conservation*: “knowing the high standard of craftsmanship of this workshop and the quality of the materials used, there seemed at first no reason for so sudden a deterioration in a textile composed of a linen warp and a woollen weft”. [Finch 1969] The main component of the flame proofing agent was ammonium sulphate. After a closer examination Karen Finch stated that a combination of the chemical used in the flame retardant, the strong incoming light, and the humid atmosphere in New York had contributed to chemical reactions that produced strong acidic products.
